date: DECEMBER 1975."

AIRFIELD PAVEMENT CONDITION SURVEY, USNAS MIRAMAR, CALIFORNIA

Technical Memorandum M-75-53-2

R. B. Brownie

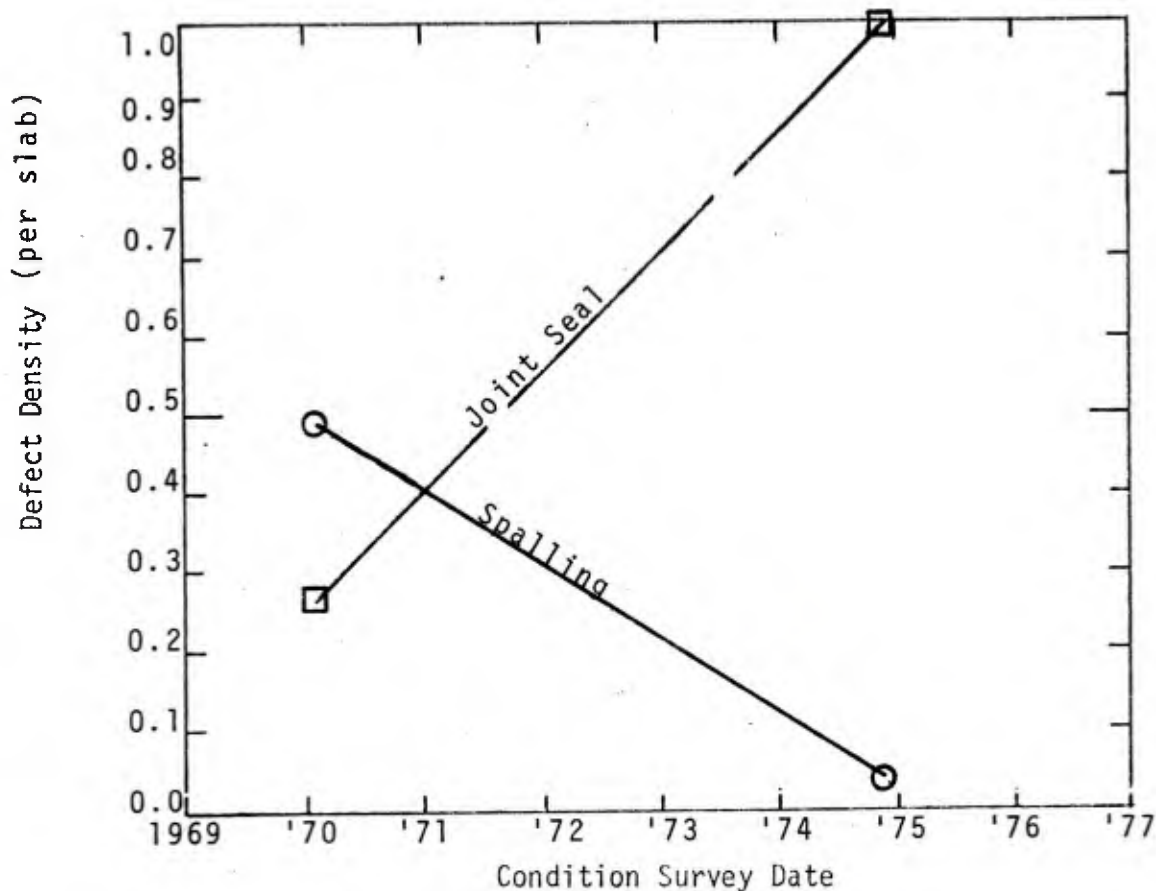
Joint seal defects have increased primarily due to age and oxidation. Spall repairs completed in 1974 have decreased the incidence of spalling.

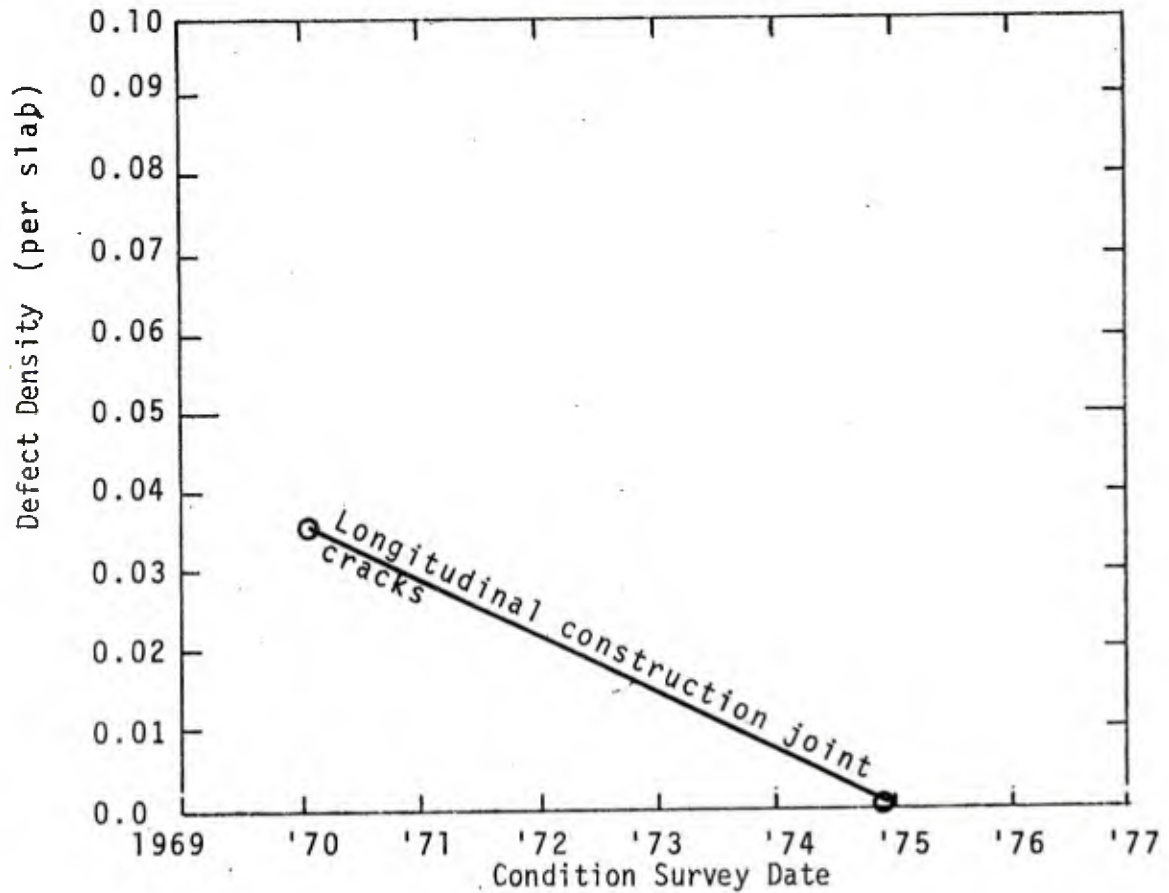
| Discrete Area | R24L-3 | Pavement Type | AC |

The rubber asphalt seal coat placed in October 1974 has covered the cracks measured in 1970. See the discrete area summary R24L-3 for additional comments.

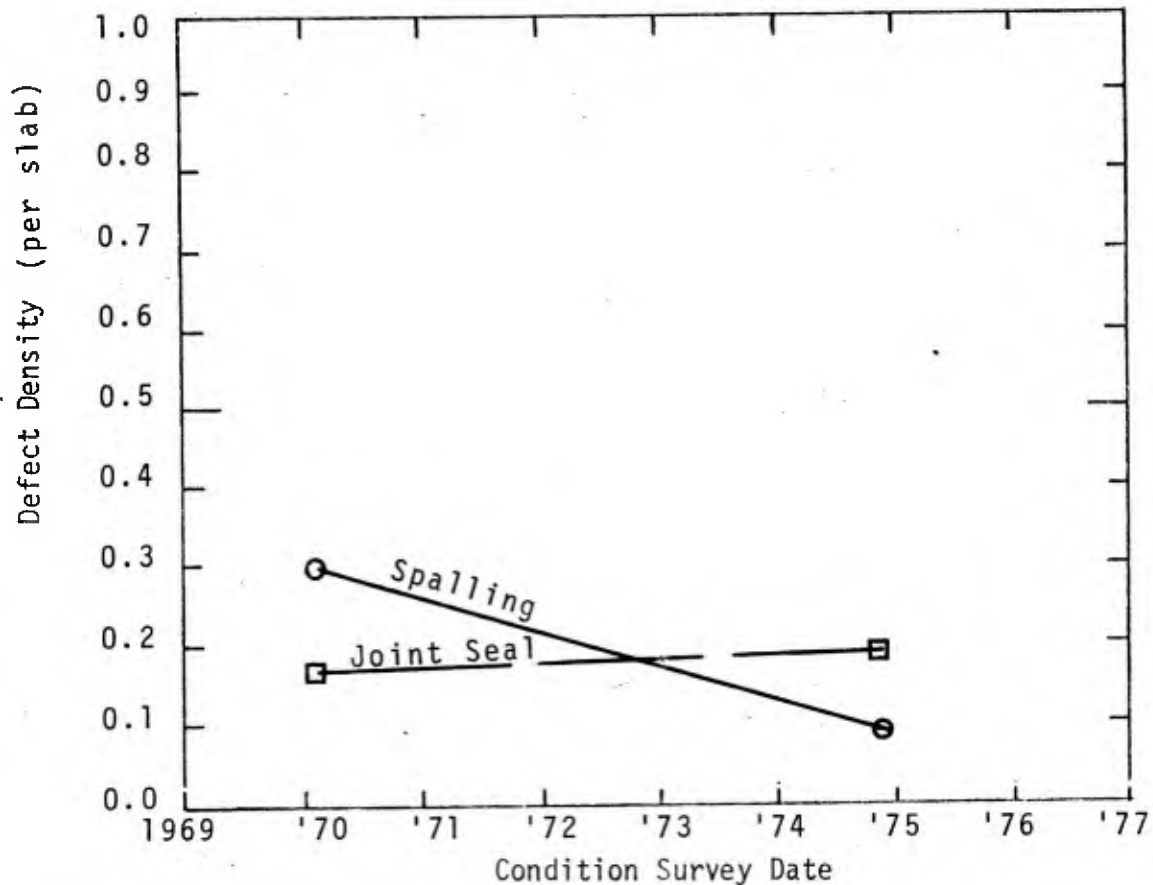
Airfield NAS Miramar Facility Runway 10-28
 Discrete Area R28-1 Pavement Type PCC
Discussion

Repairs have apparently reduced the number of spalls noted on this seldom-used runway.
